Environmental and Runway Surface Conditions During Friction Tests at North Bay Airport: January-February 2002

LM-SMPL-2002-0220
TP 14158E

Nirmal K. Sinha

October 2002

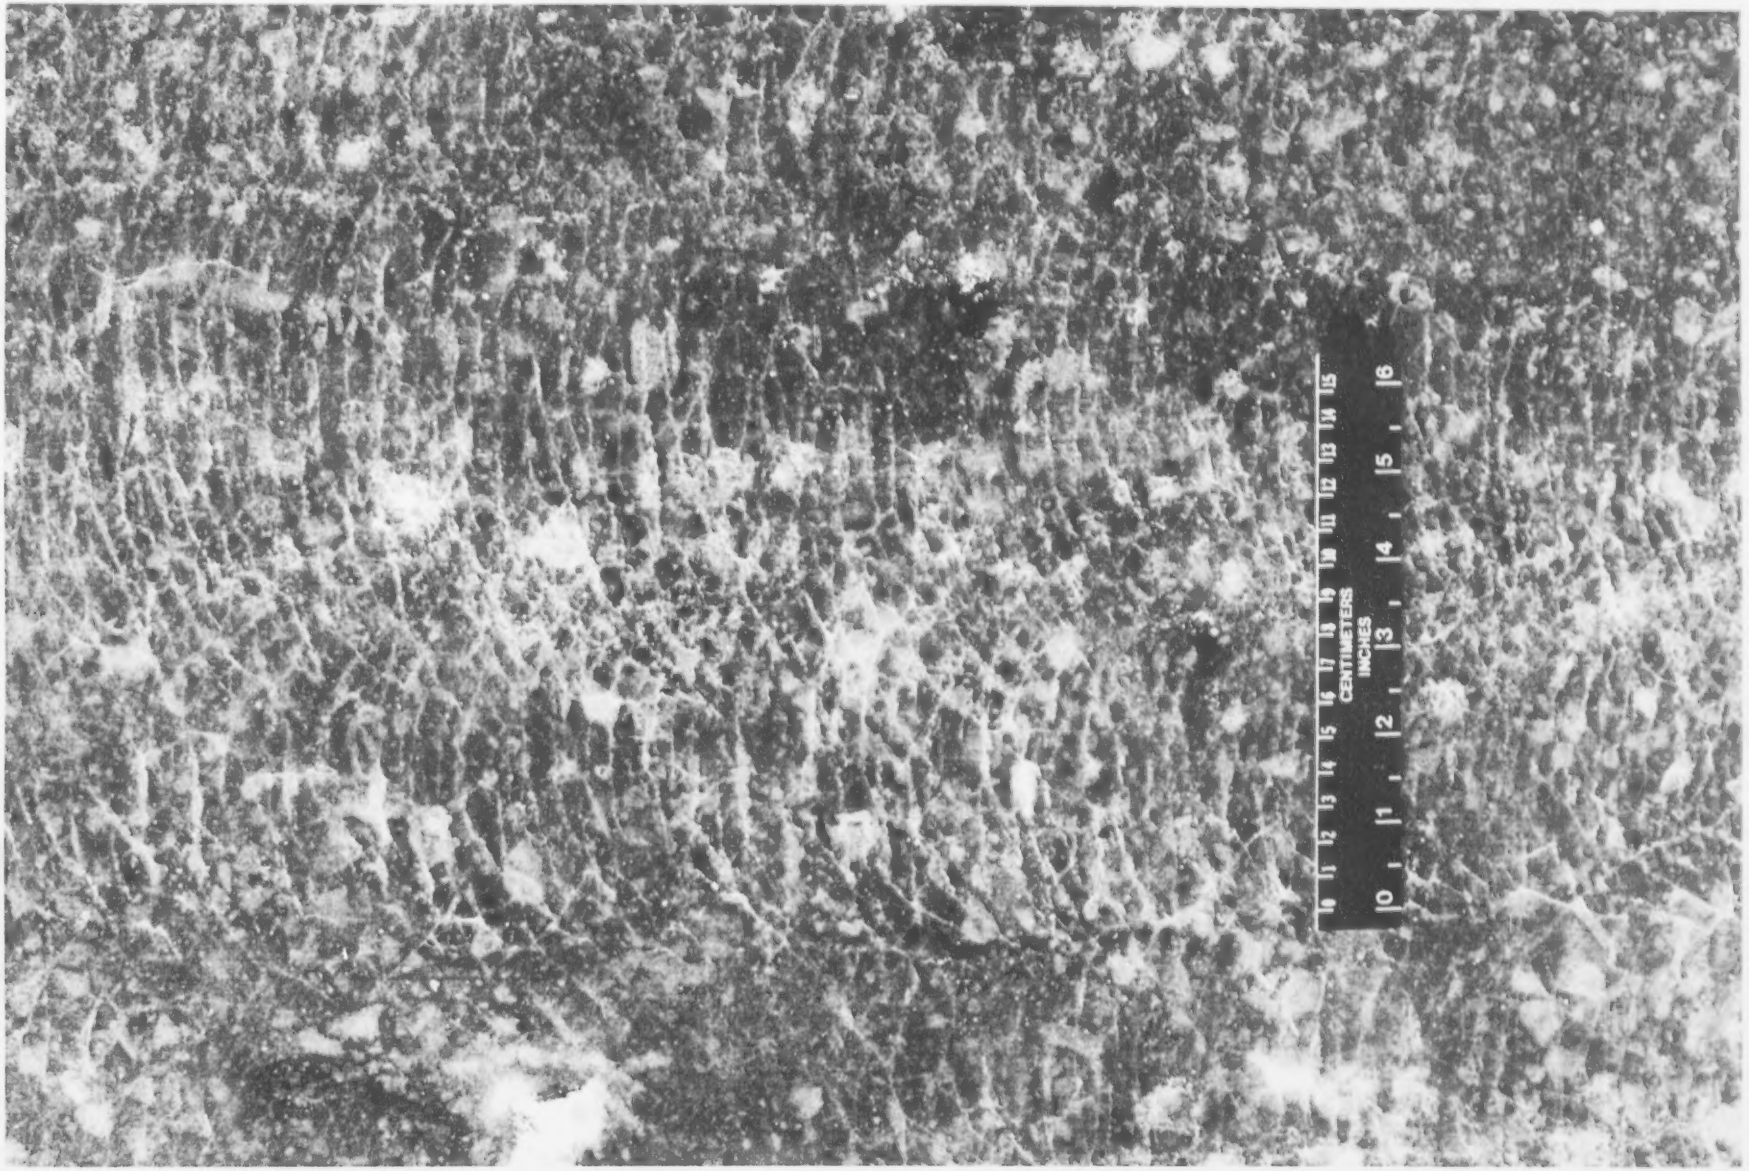
February 2, 2002 16:15
North Bay, Ontario
Test Number 02.33.06, Project 437
Runway 1331, West of Center Line
IRV/ERD Comparison, Variable Slip on COMPACTED SNOW
IRV-A/C Tire, High Load, High Pressure

Conditions after all tests: Air Temp. -11.6 C.
Surface Temp. -11.3 C. (Compacted snow) to -11.5 C. (Icy Crust)
Very uniform and highly compacted, with a texture. Some ruts were created by ERD tires. Repeated test runs had caused an icy crust to form on the raised parts of the texture.
NOTE: These conditions also serve as the pre-test conditions for the next set of tests

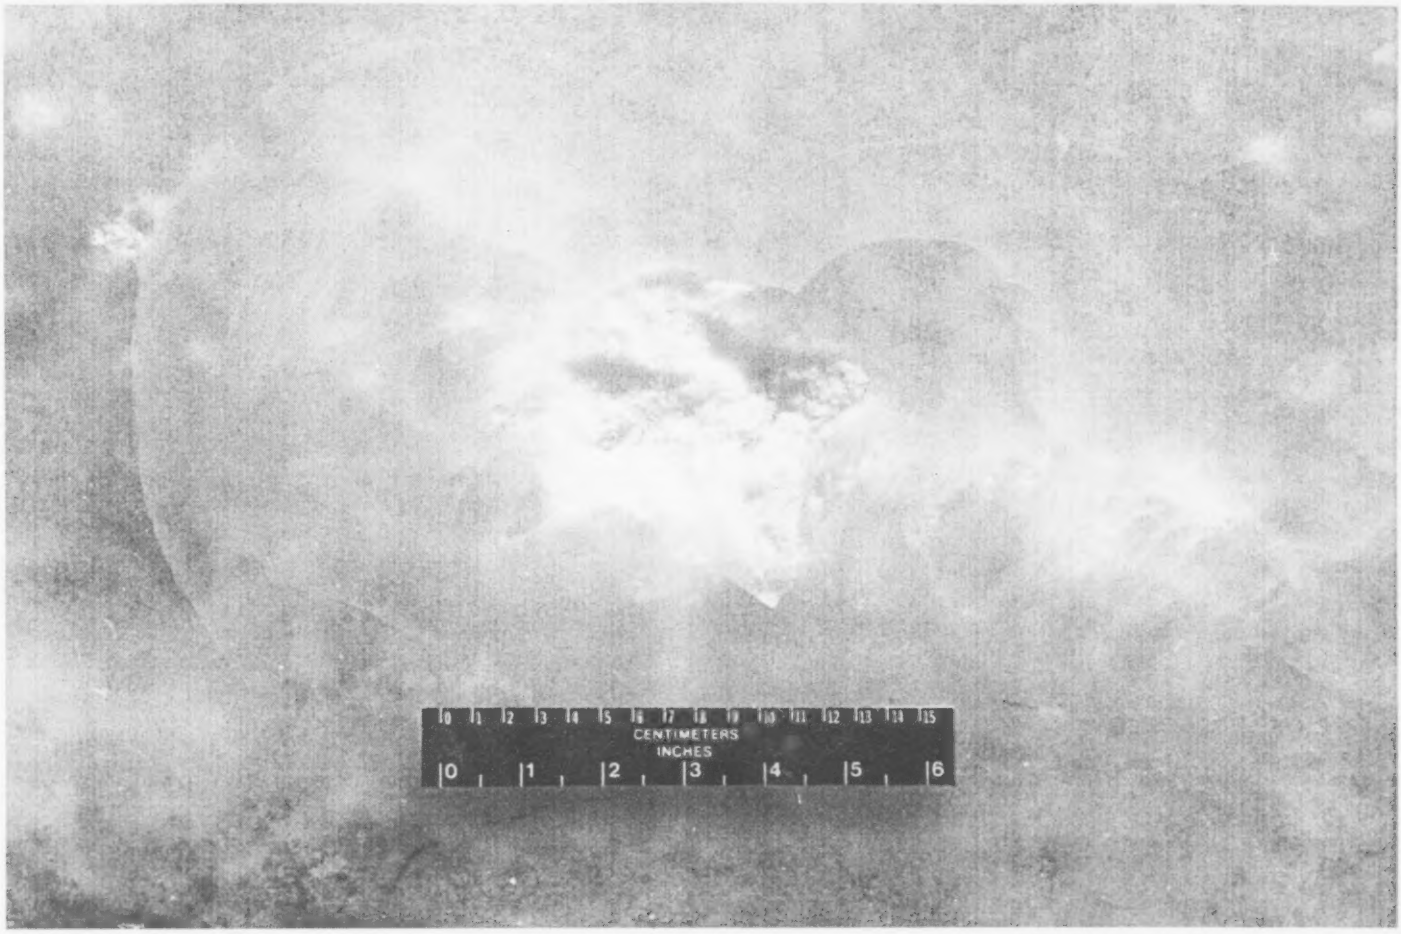
February 2, 2002 16:15
North Bay, Ontario
Test Number 02.33.05, Project 436
Runway 1331, West of Center Line
IRV/ERD Comparison, Variable Slip on ICE
IRV-A/C Tire, High Load, High Pressure

Conditions After All Tests: Air Temp. -11.6 C.
Surface Temp. -4.1 C. (Clear Ice) to -5.9 C. (Thicker, Bubbly Ice)
The ice test strip was now exhibiting severe cracking in some areas, and long strips of herring bone cracking were visible.
NOTE: These conditions serve as the pre-test conditions for the next series of tests, which began immediately: Test number 02.33.09, Project 432.

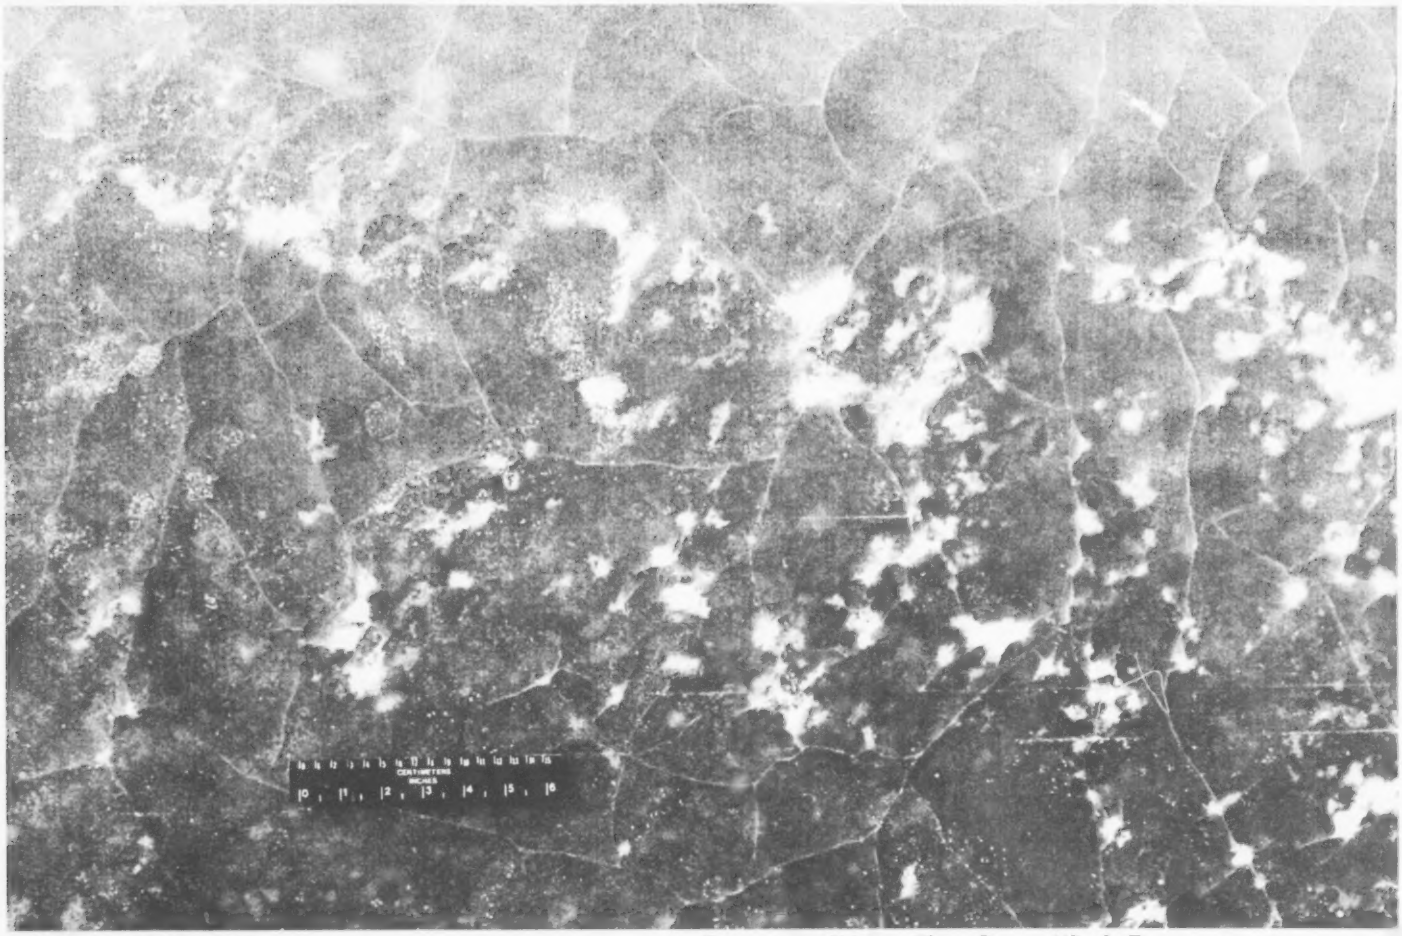
February 4, 2002 10:45
North Bay, Ontario
Test # 02.35.01, Project 101
Runway 13/31, 13 Direction
Ice was cracked throughout test surface
as a result of snow removal that morning.

Pre-test conditions: Clear, Sunny, Windy Day
Air Temp. -20 C.
Ice temp. -10.5 C. (Thin, Clear Ice)
to -12.7 C. (Thick, Bubbly Ice)
NASA-GT, FAA-RFT, IRV, TCSF-TURBO,
FAA-BV11, ERD; 5 runs @ 65 km/h

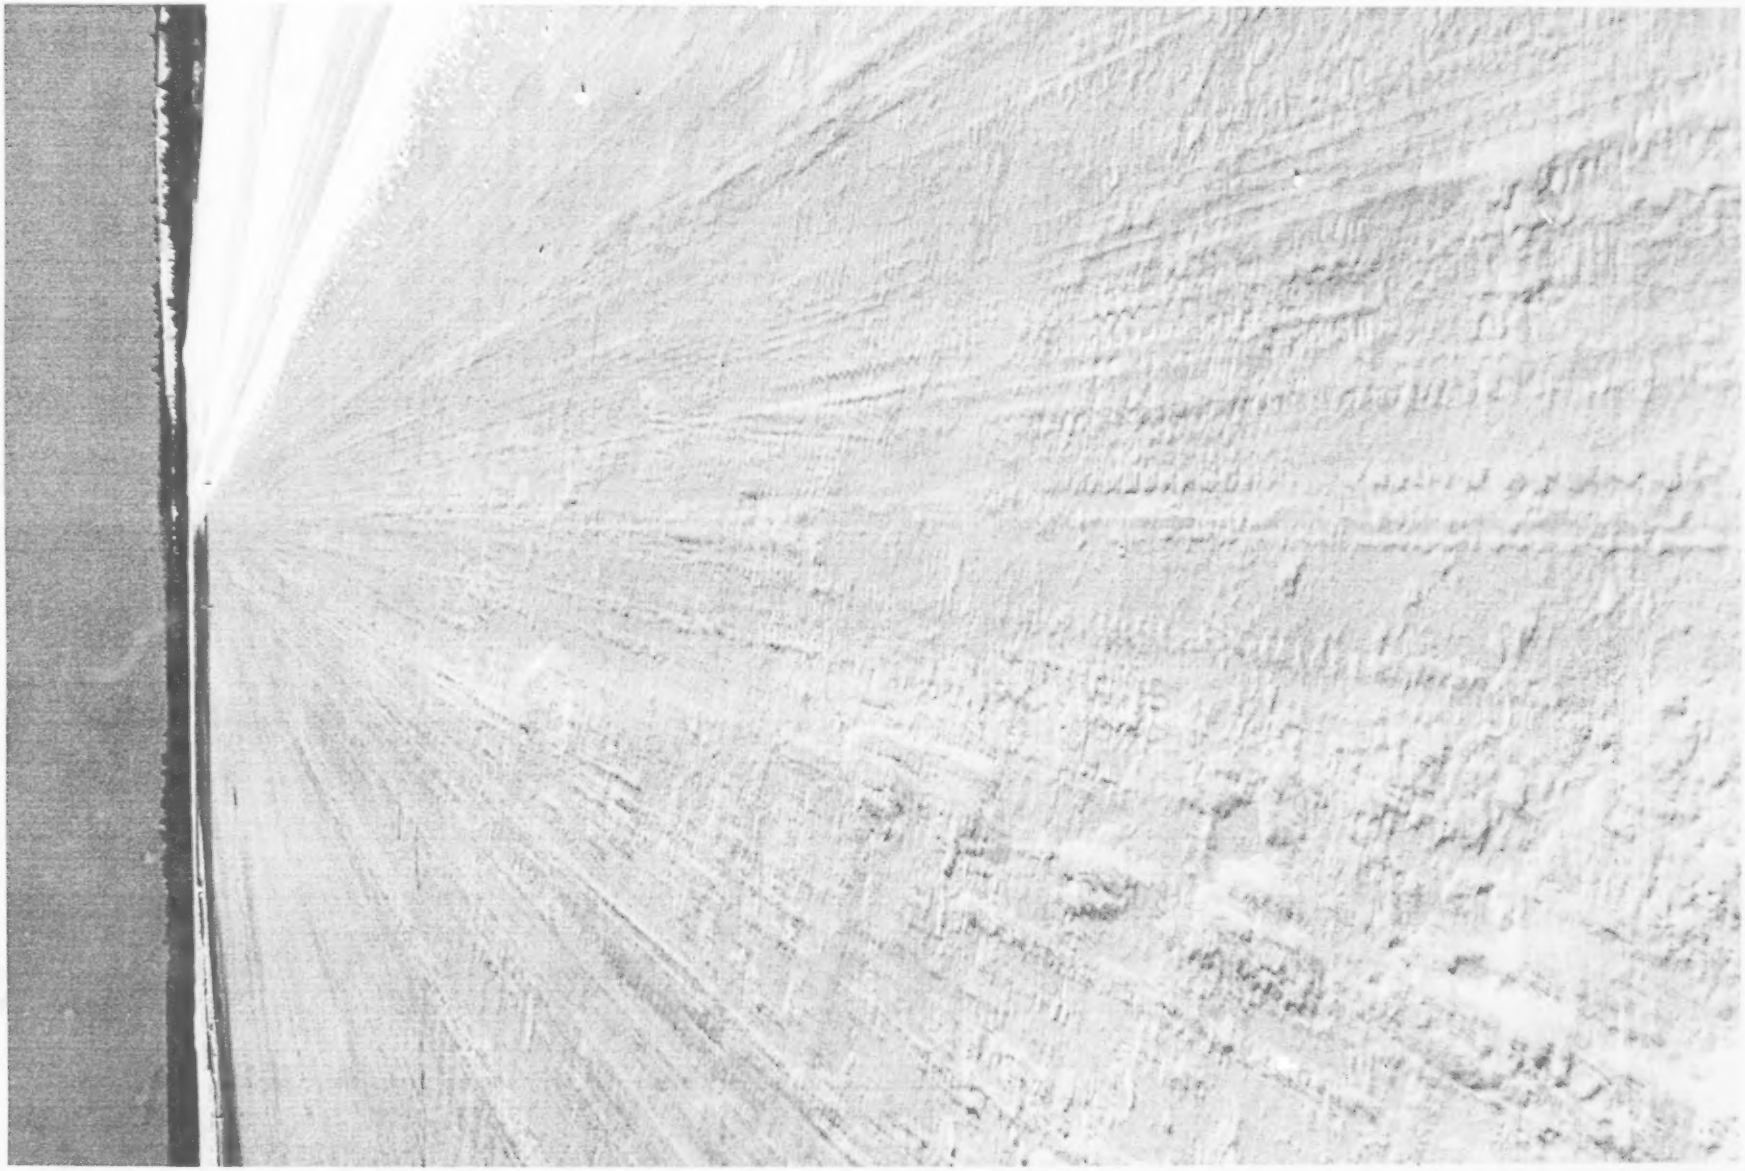
February 4, 2002 10:45
North Bay, Ontario
Test # 02.35.02
Project 102
Runway 13/31, 31 Direction
Test surface was compacted snow

Pre-test conditions:
Air Temp. -20 C.
Snow temp. -15 C.
Clear, Sunny, Windy Day
NASA-GT, FAA-RFT, IRV, TCSF-TURBO,
FAA-BV11, ERD

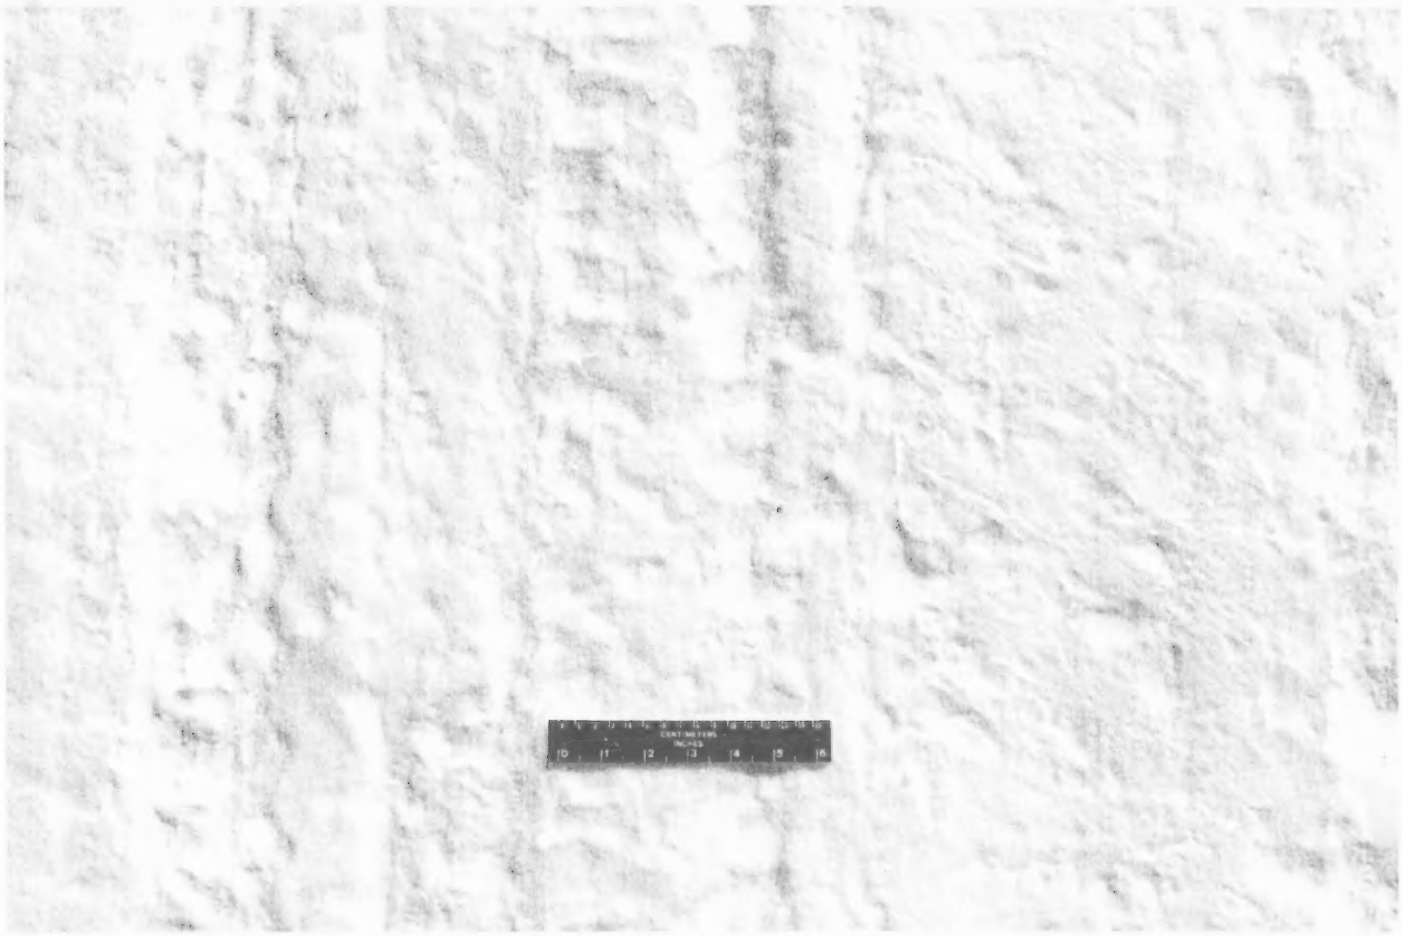
February 4, 2002 10:45
North Bay, Ontario
Test # 02.35.02
Project 102
Runway 13/31, 31 Direction
Compacted snow

Pre-test conditions:
Air Temp. -20 C.
Snow temp. -15 C.
Clear, Sunny, Windy Day
NASA-GT, FAA-RFT, IRV, TCSF-TURBO, FAA-BV11, ERD

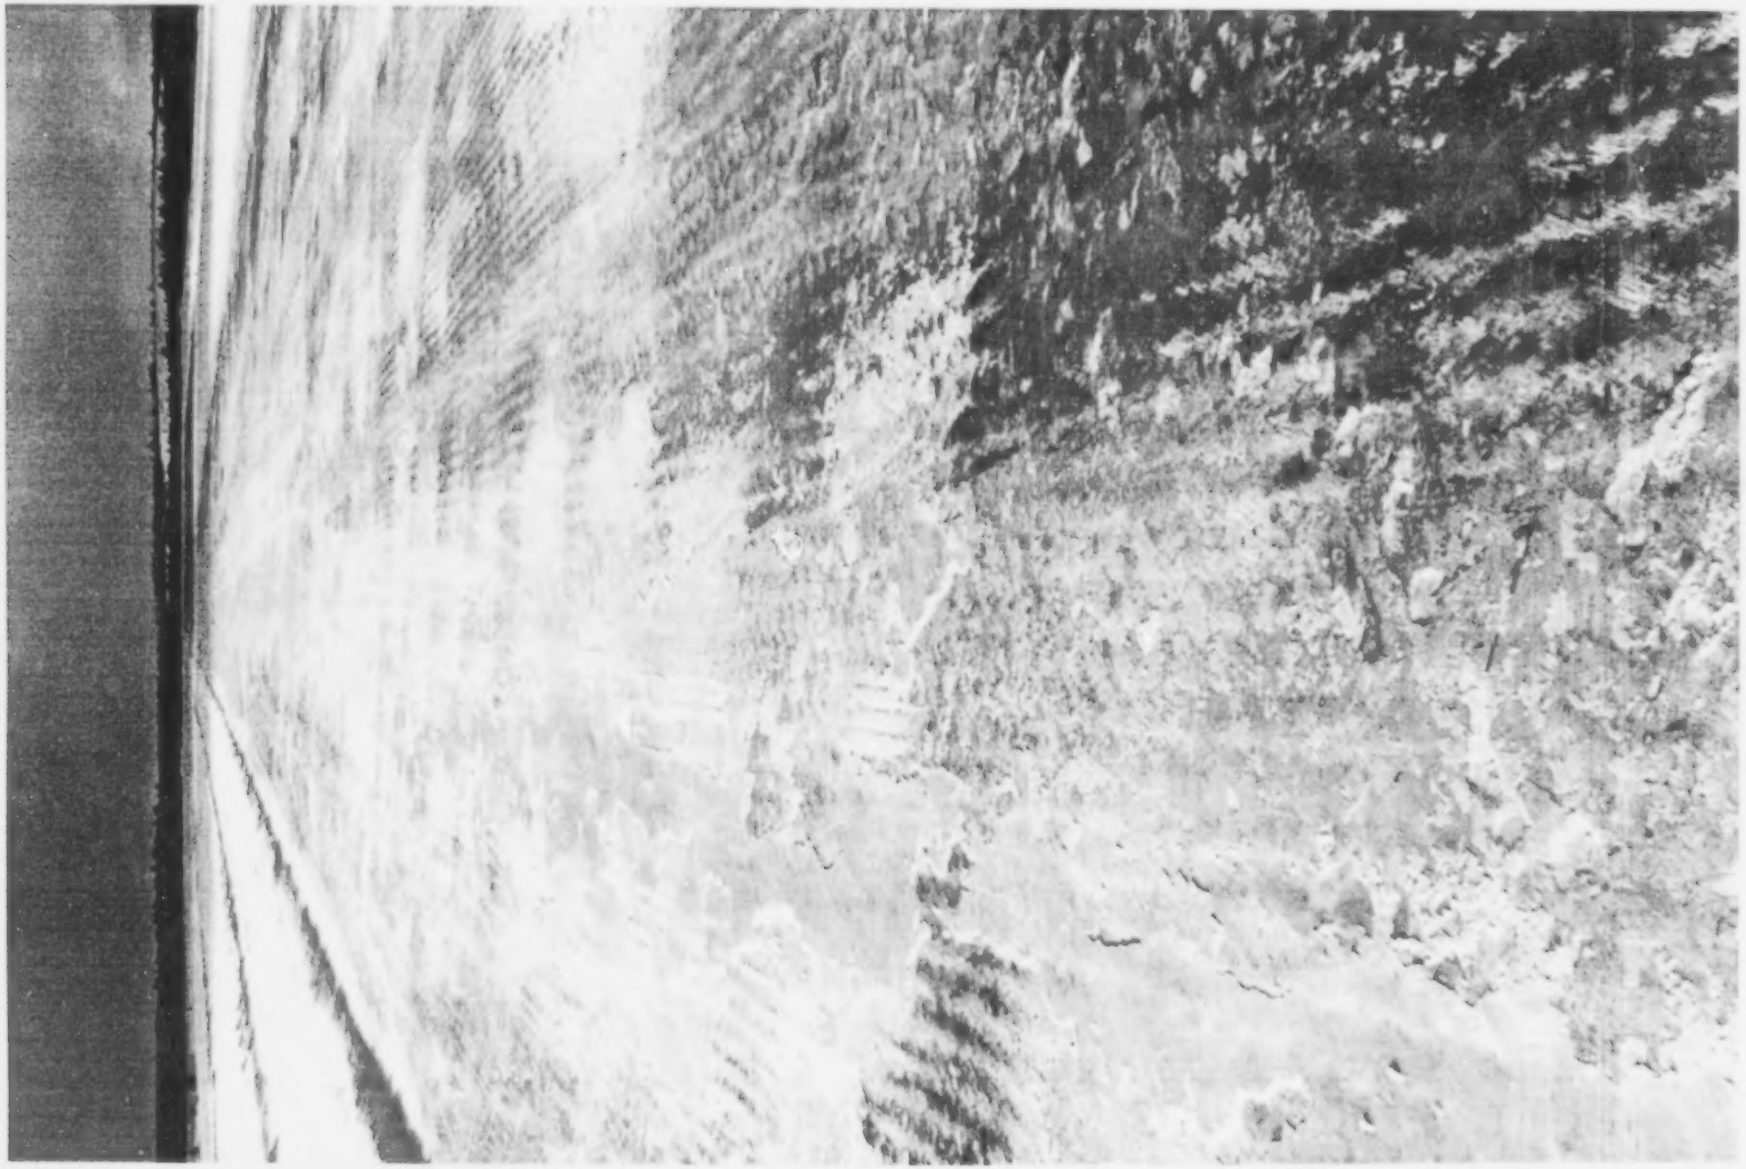
February 5, 2002 14:55 , North Bay, Ontario
Test # 02.36.01, Project # 107
Runway 13/31, Direciton 13, 7 Runs at 65 km/h
Pre-Test Conditions:
Air Temp. -6.3 C., Ice Temp. -6.1 C.
NASA-GT, FAA-RFT, IRV, TCSF-TURBO, FAA-BV11, ERD

Ice test section was reflooded the previous night; wind and blowing snow had caused the surface to become very non-uniform and crusty (shown). Snow removal equipment left the surface rough, appearing partially scarified.
There were many areas of cracking and areas of frozen slush that had flaked off of the base ice.

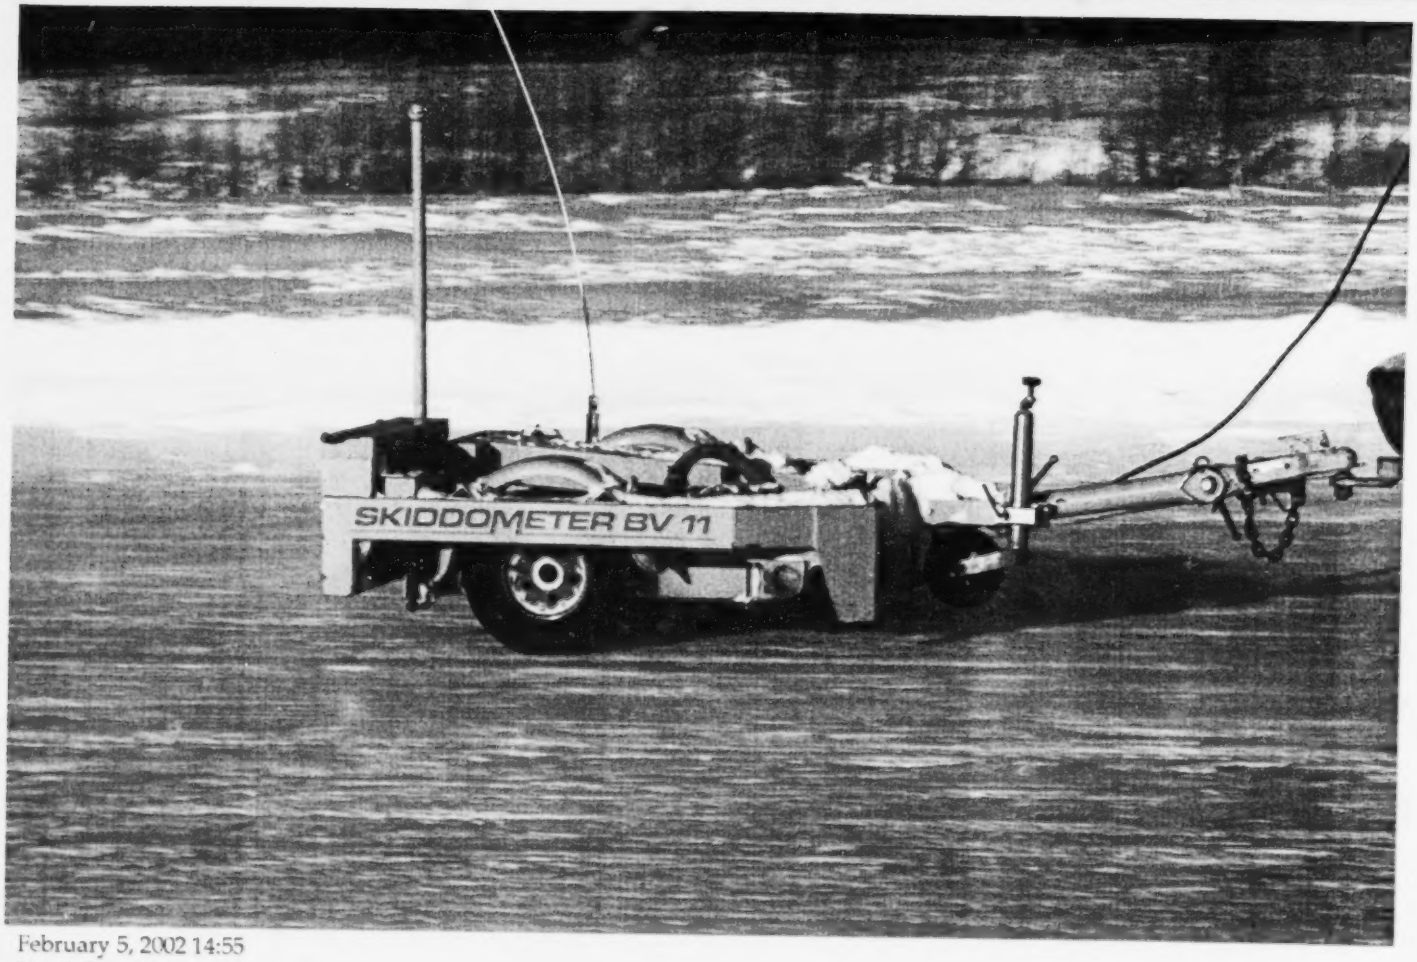
February 5, 2002 14:55
North Bay, Ontario
Test # 02.36.02
Project # 108
NASA-GT, FAA-RFT, IRV, TCSF-TURBO, FAA-BV11, ERD
7 Runs at 65 km/h

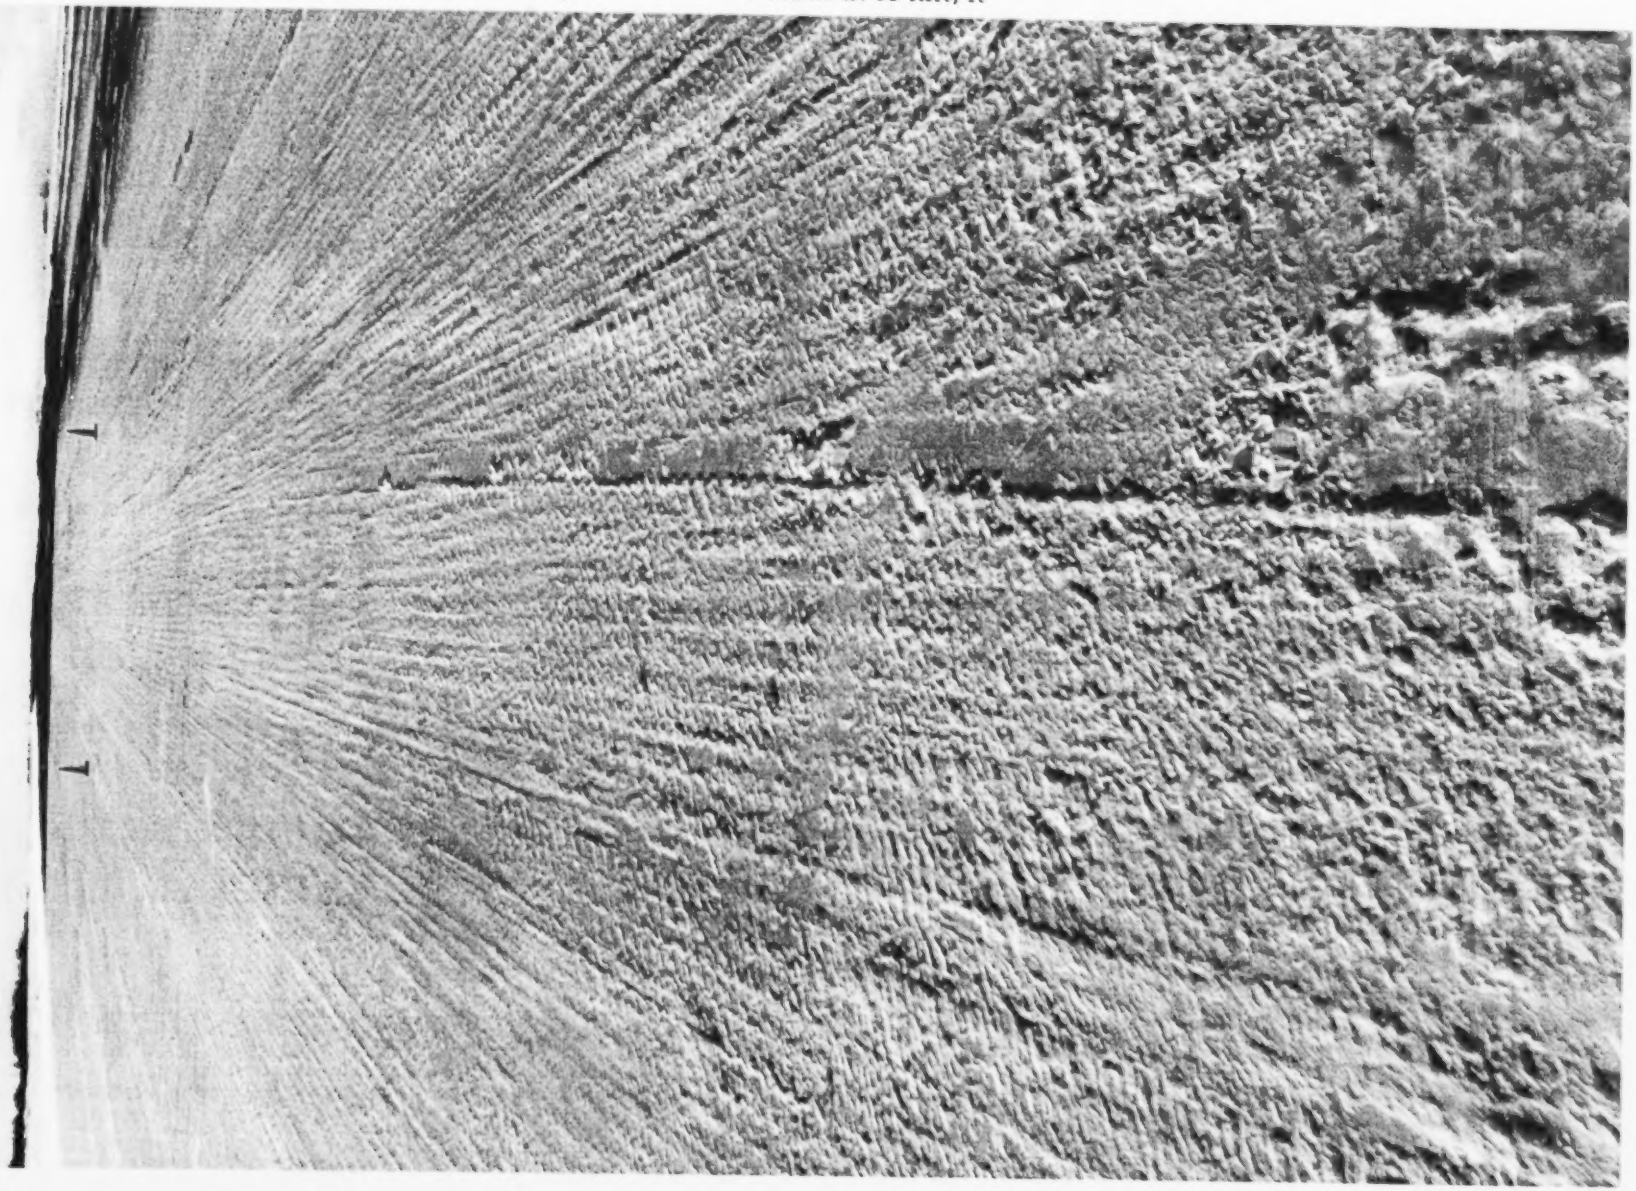
February 6, 2002 08:36
North Bay, Ontario
Test Number 02.37.01
Project 800
Runway 1331 South, 31 Direction
A/C Runs- Cessna 414

Pre Test Conditions:
Surface was bare and dry with 5% ice patches
Air Temp. -8.8 C.
Surface Temp. -8.5 C. (Pavement) to -8.5 C. (Ice Patches)

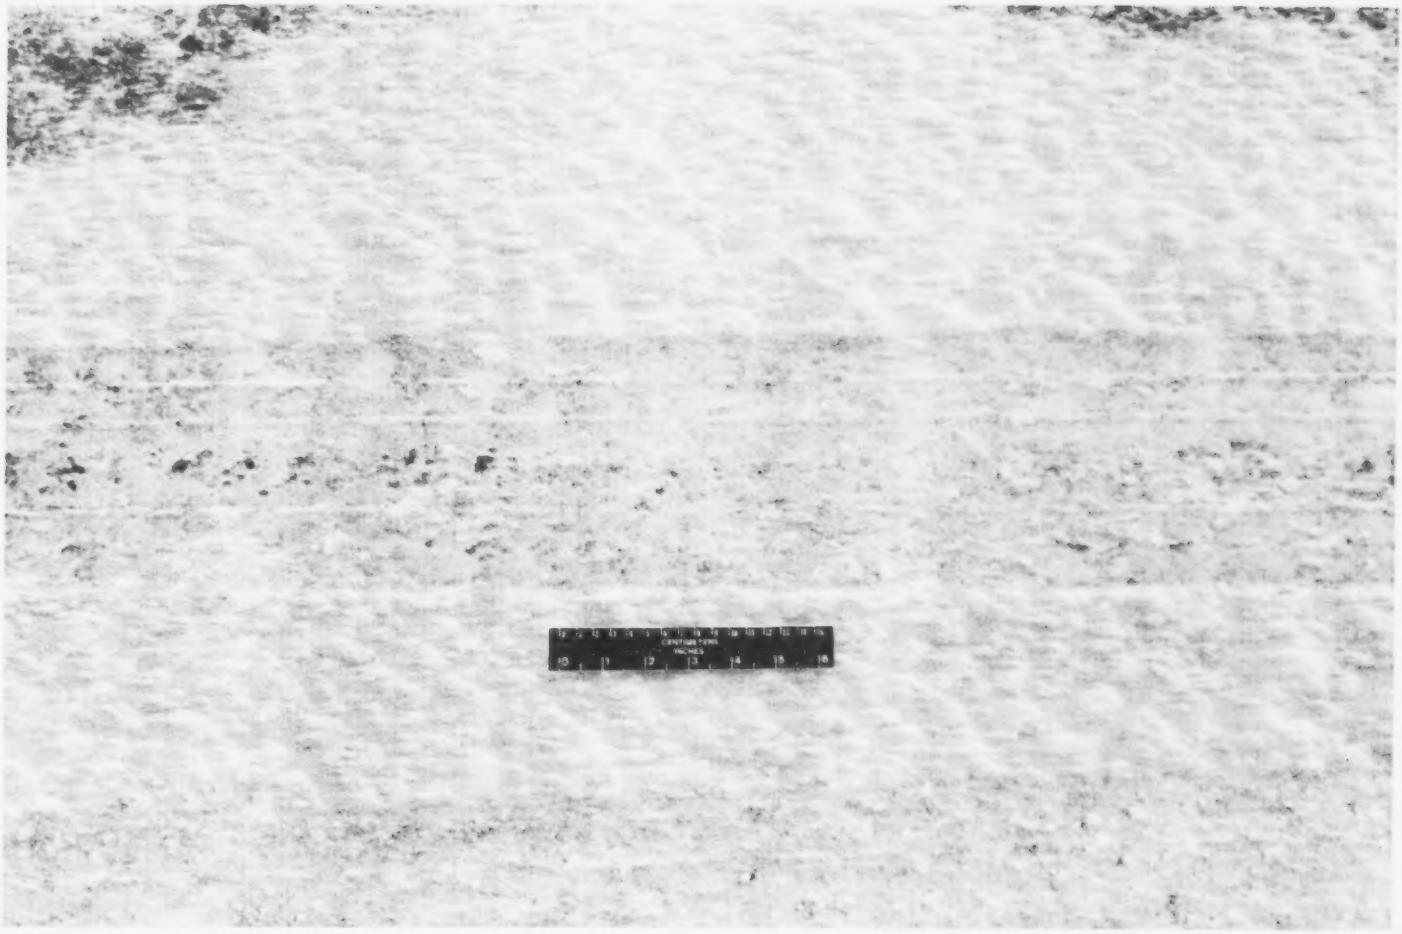
February 7, 2002 17:40, North Bay, Ontario
Test # 02.38.05 , Project # 801
Post-Test Conditions:
Air Temp. -1.5 C.
Surface Temp. -2.7 C. (snow patches)
A/C Tire Print on Test Surface
